Test Report

ABC Company PTU Pinion Test

Conducted by: Peak innovations Engineering

David Archer
12/16/2008

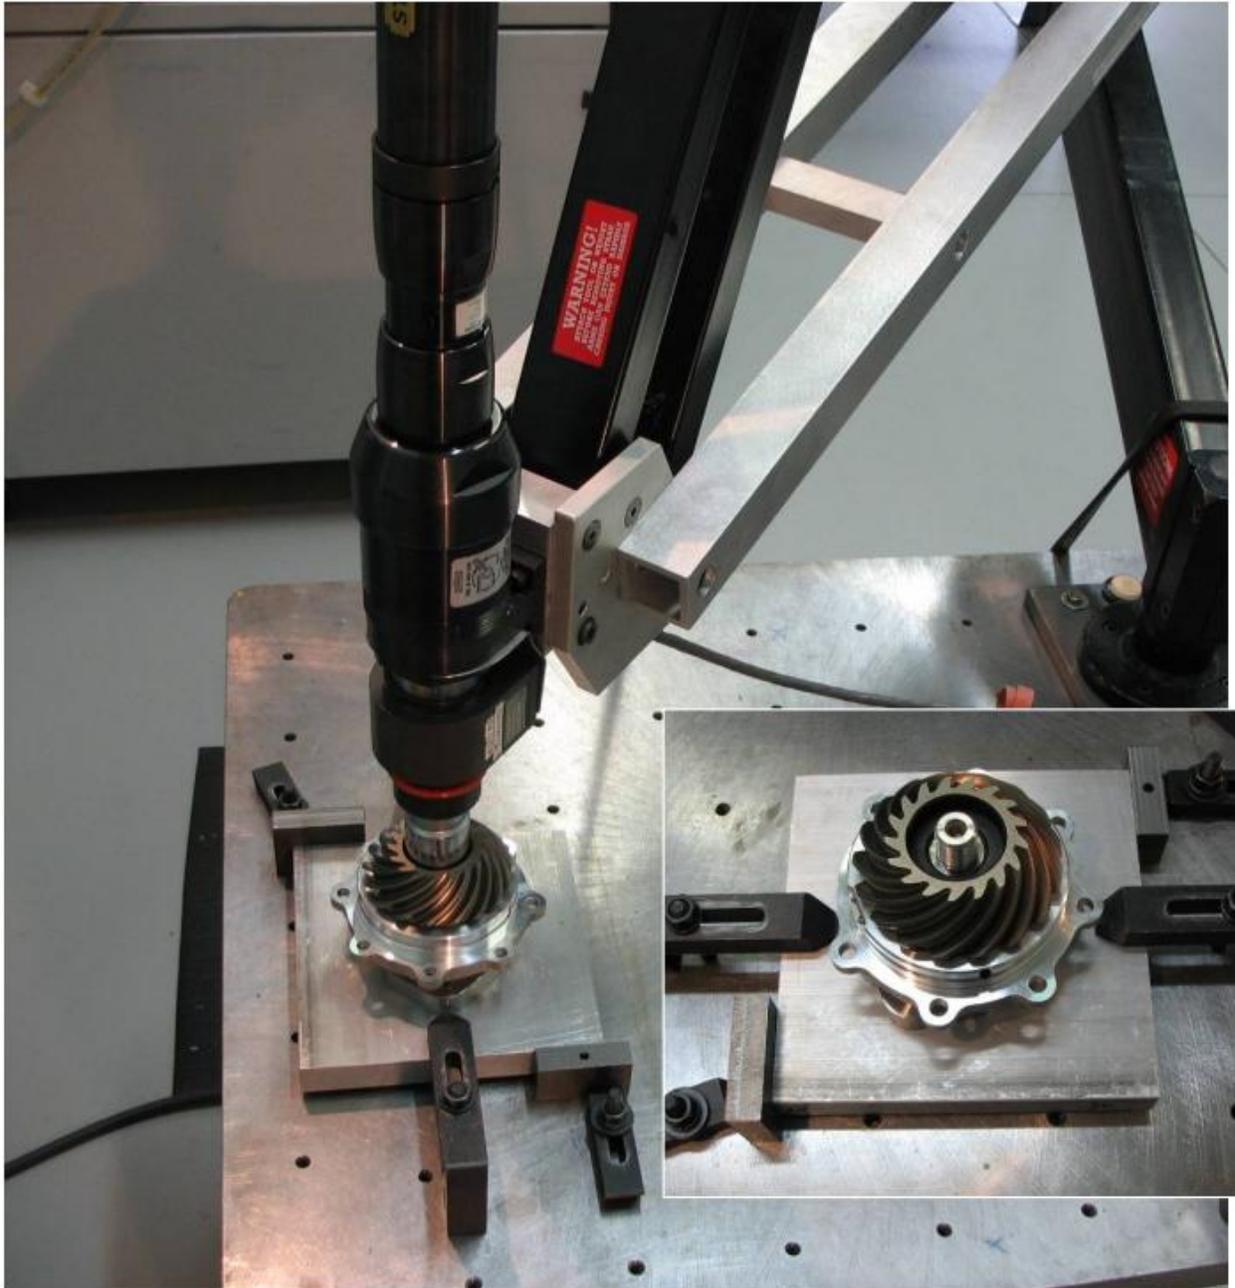
Test setup- Joint shown inset with nut removed

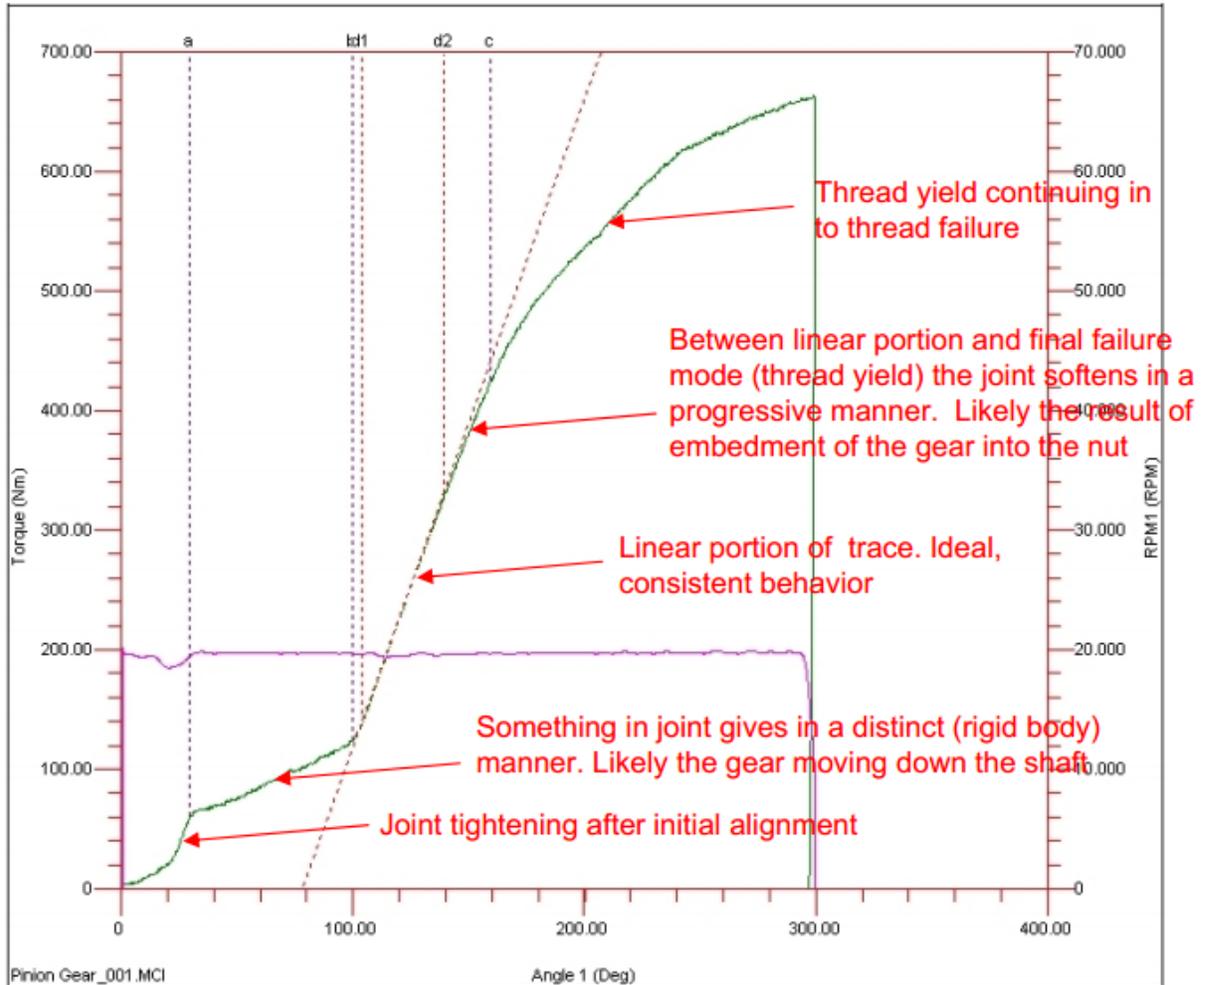
Below is an annotated torque-angle- RPM trace of the rundown. A time limit caused the controller to shut-off in 3 seconds. So the ending event of this trace was tool shut-off. The nut was immediately tightened a second time resulting in failure due to thread strip at a maximum torque of 813.1N-m at an additional angle of 120 degrees.

Torque-Angle-RPM trace aligned at 3 N-m (angle=0 at 3 N-m)

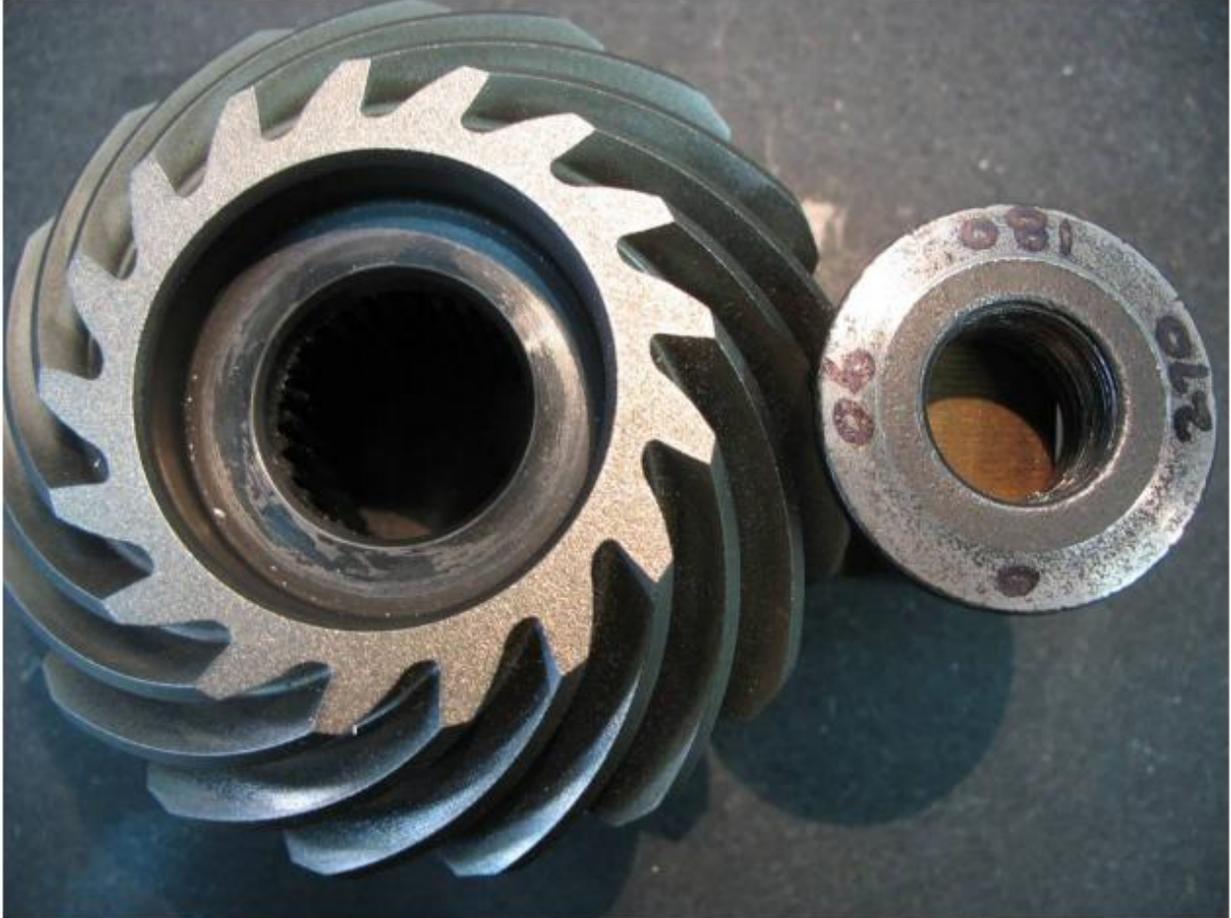
The torque-angle trace showed that failure was by thread strip, primarily in the nut. Because the trace also showed a yield event prior to thread strip, separating the failed joint was desirable to see if the cause of this even could be determined. After much effort, the nut and gear was removed from the shaft. The mating surfaces are shown below and in more detail on the following page.

Mating Joint Surfaces

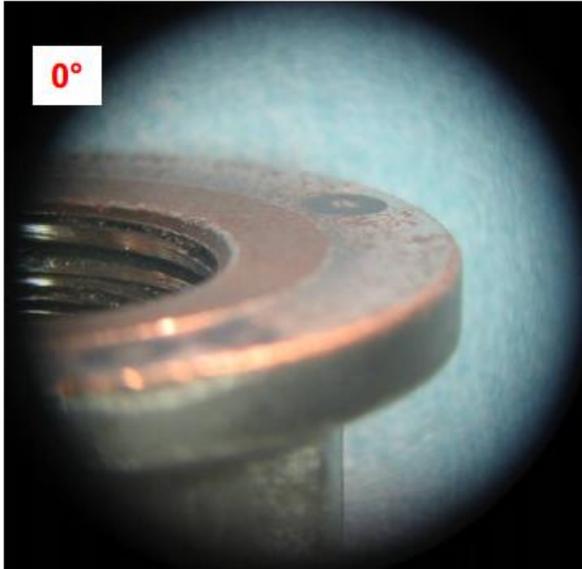
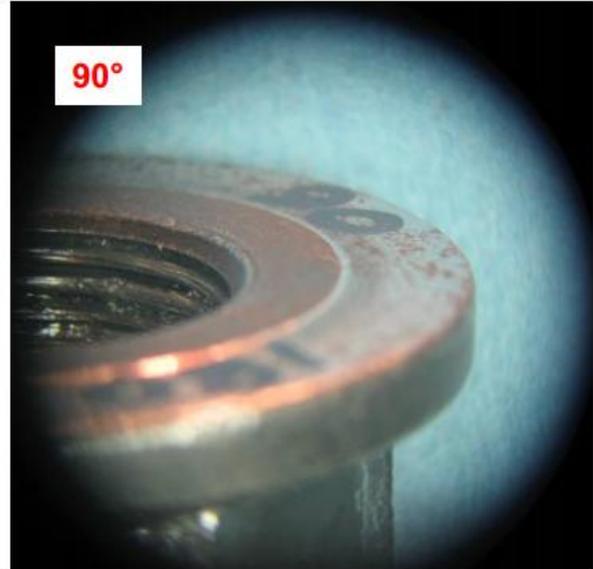
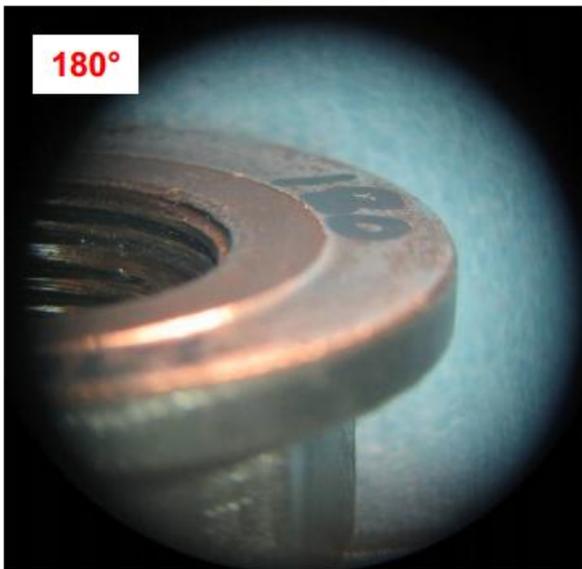
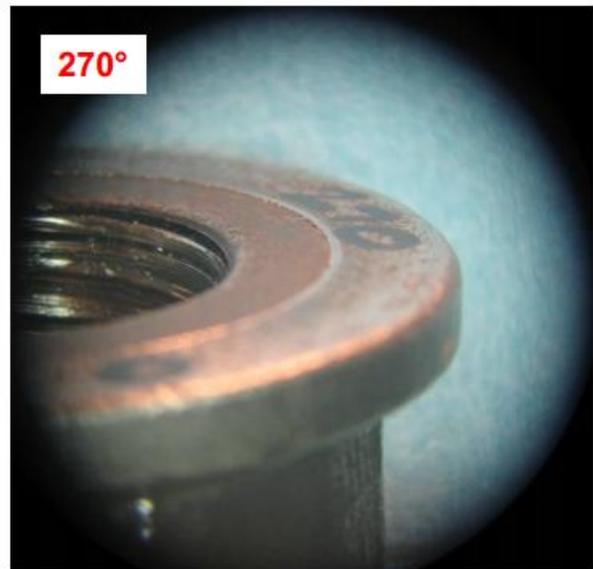
Examination of the nut showed embedment and more specifically embedment on a plane not square to the shaft axis. The photos below show the contact plane at 90 degree intervals with the location without embedment 0 degrees. The maximum offset between the contact surface and the inner nut surface at 180 degrees was approximately 0.15mm.

- The torque required to move the gear to contact with the shaft (point b) does not contribute to clamp load. If this value is variable, joint capacity will also vary
- It appears that the nut did not contact the gear in a flush manner. If pressure against the nut face varied by angular orientation, the axial load (and therefore the tightening torque) at which embedment would start is reduced. It appears likely that if the shaft axis was normal to the plane of the gear pocket, the linear portion of the trace could be raised from point d2 to the start of thread yield, point c

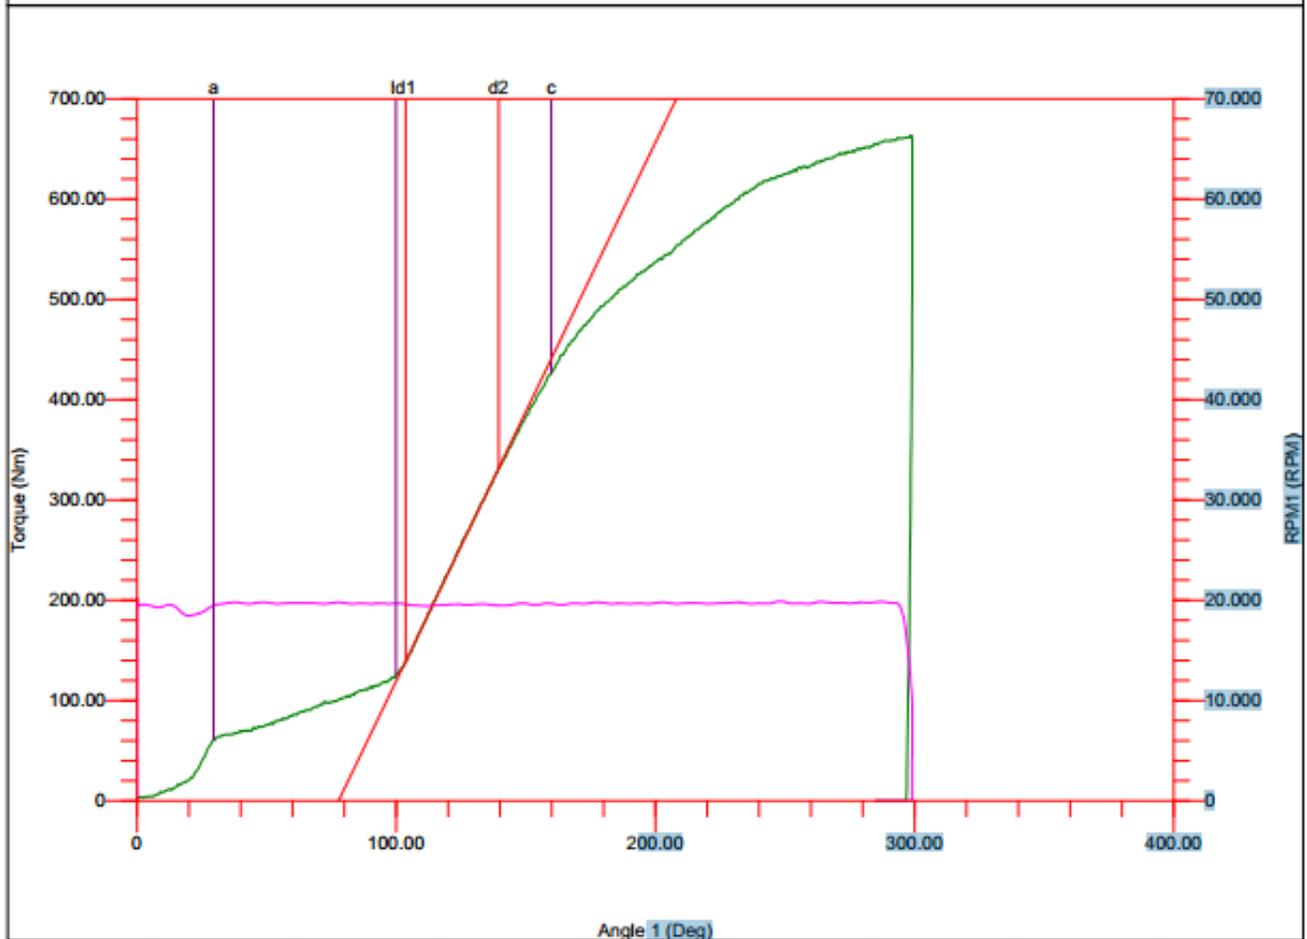
MODES: Failure by thread strip. Timer halted this rundown. subsequent additional torque led to thread failure at a peak torque of 813.13 N-m at 119.6 additional degrees rotation.
 OBSERVATIONS: See body of report.
