Test Report

# Company X Torque- Angle to Failure Testing

Conducted by: Peak innovations Engineering

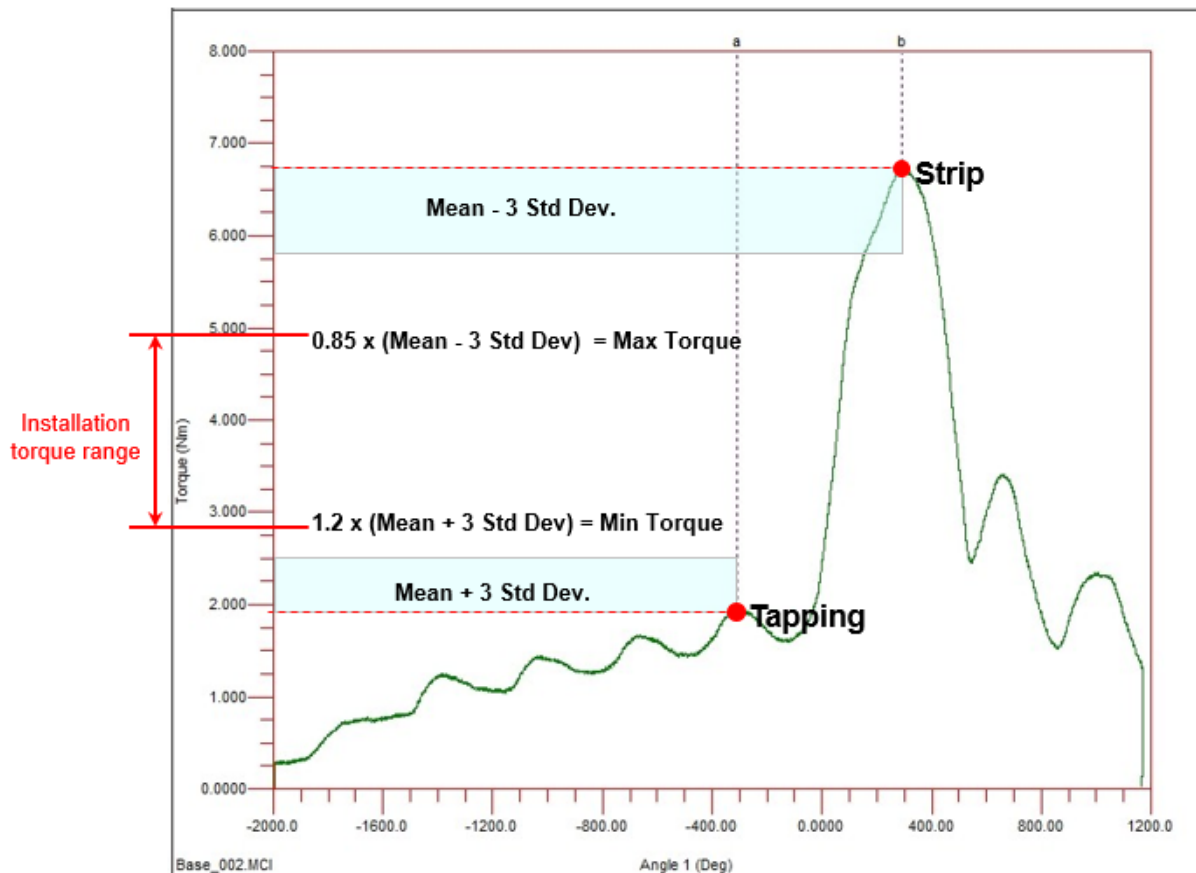
**Illustrative Torque-Angle To Failure Trace  
(with selection of tapping and strip points)**

The results that follow report two values picked from each rundown. The Tapping and Strip torque represent the peak torque prior to screw seating and the ultimate torque at failure, respectively. Typically installation torque is established to be between these values. While the mean of each is usually used as a starting point, their variability should be taken into account when establishing installation torque. The results data includes mean +/- 3 standard deviation values for this purpose.

It should be noted that the torque-angle trace is not a foolproof indication of joint stiffness, as friction variation during the rundown can also cause changes in the slope of a torque-angle trace.

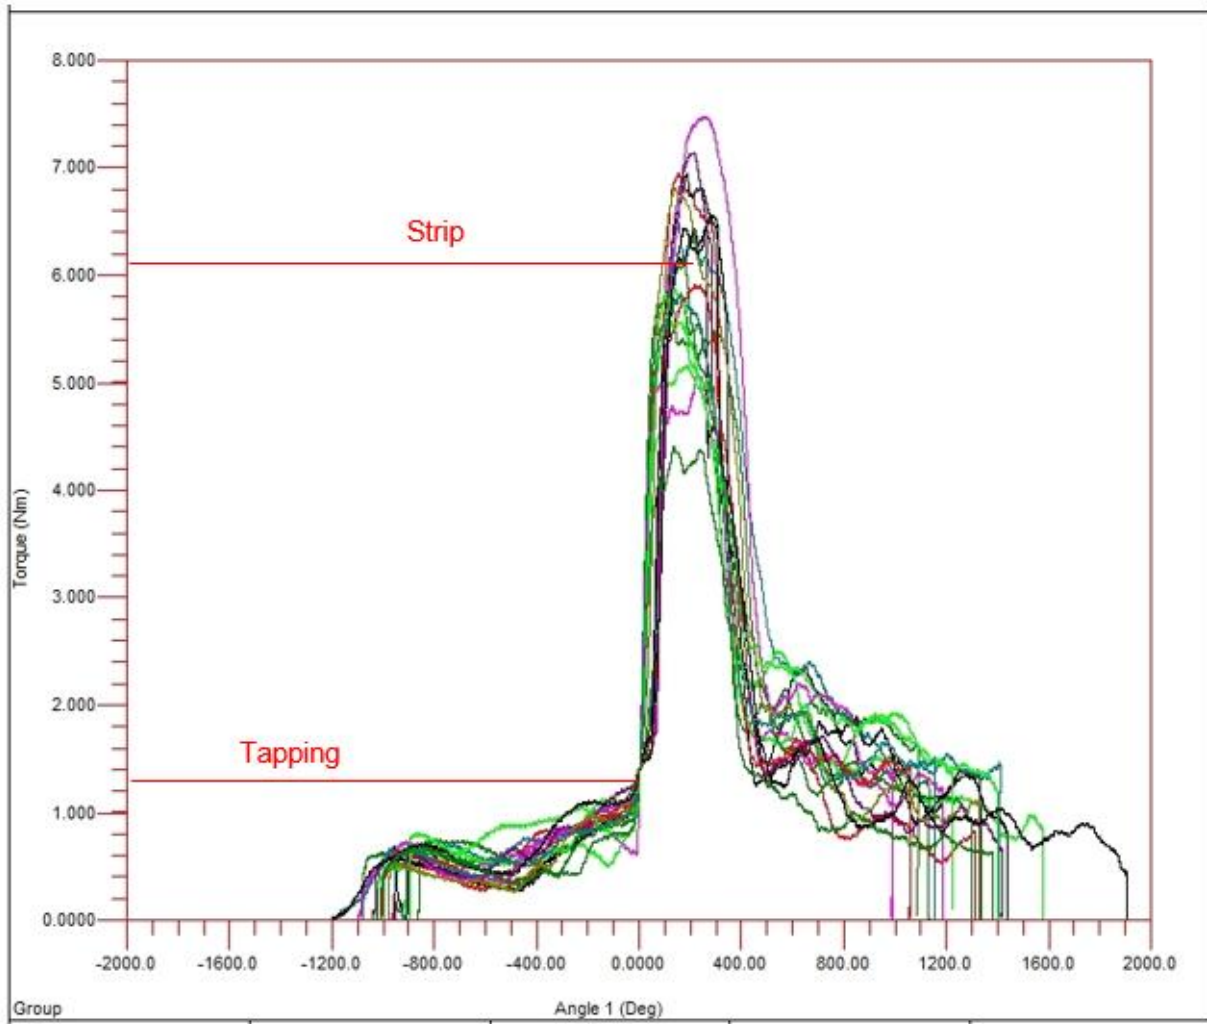
Torque-Angle traces from which reported data was taken are shown below. Mean values are annotated.

**Traces aligned to zero degrees at 1.25 N-m**

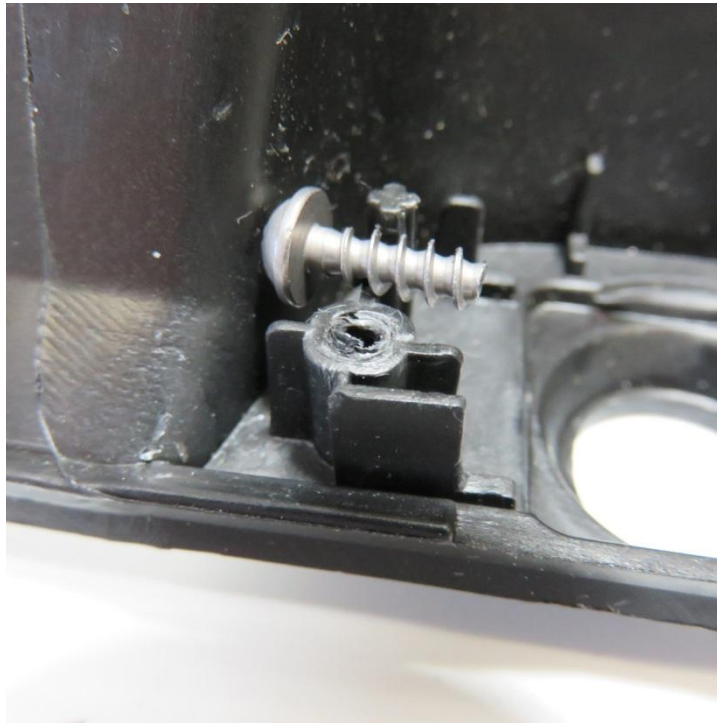
Typical Surfaces

Failure Mode: Nut member strip
